Instant, actionable insight to eliminate water waste

APANA™ Smart Water Analytics

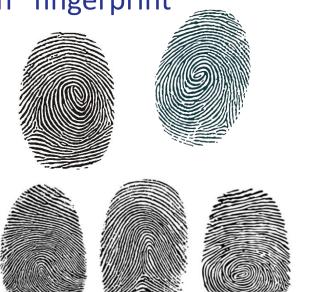
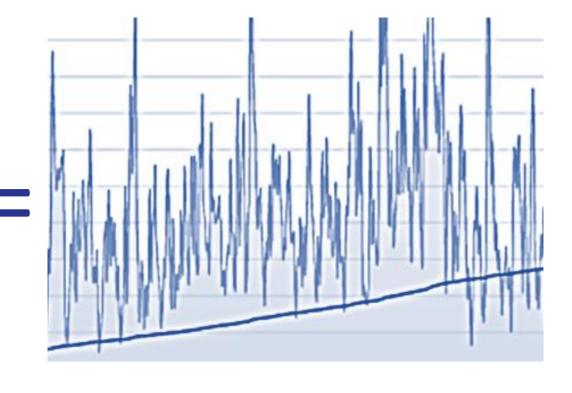
Every device/process that uses water creates its own "fingerprint"

- Faucets
- Hoses
- Water softeners
- Cooling towers
- Sprinklers
- Dishwashers
- Toilets

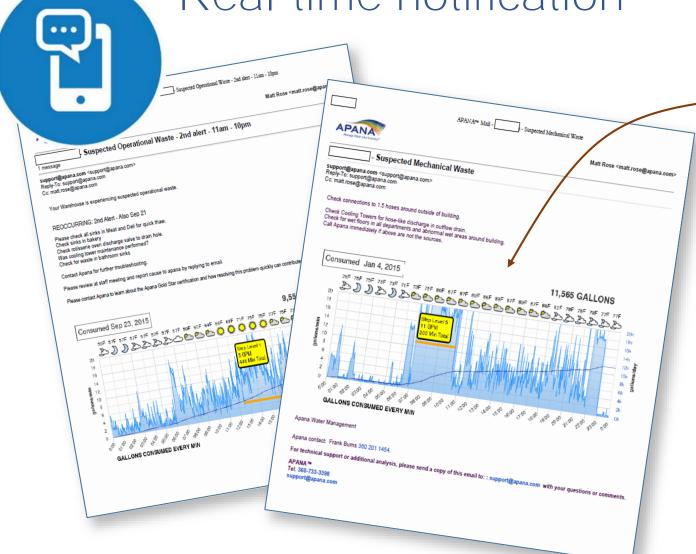
Real-time notification

Your location is experiencing a 11 GPM leak beginning at 7:05 lasting for 200 min.

Check connections to 1.5 hoses outside the building

Check cooling tower for excessive discharge in outflow drain

Contact APANA if above are not the source

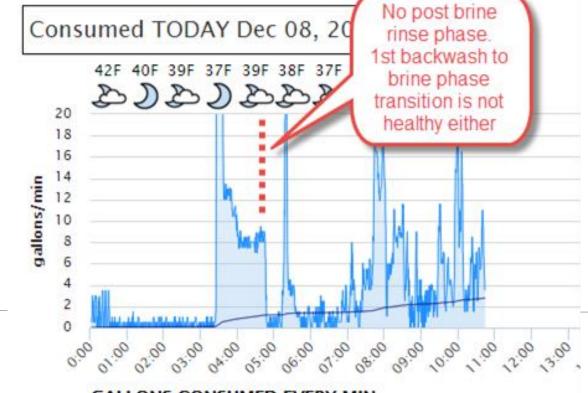
Water Softener – a 3x failure

Water softener has three separate problems.

- 1) used 40% more water than required
- 2) end of backwash phase/start of brine phase shows a valve close issue
- 3) final rinse phase does not use enough water this indicates a valve or programming issue.

The location was told exactly what was wrong and given detail to show their local service provider.

Problems were resolved. Salty water was eliminated and the total consumption was reduced to the correct amount saving over 300 GPD = 100,000 gal of water a year

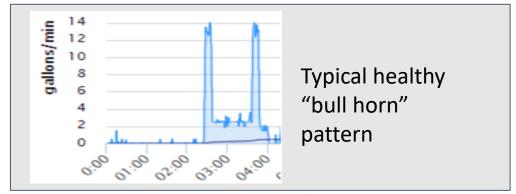
Cooling tower low flow

While a construction crew was working they mistakenly shut off water to the cooling tower.

An alert was sent to the customer who did not realize water had been shut off.
